Working Paper No. 118
August, 2012

**Managing and Coping with Urban Floods:
Lessons from the Kurnool Flood of 2009
in Andhra Pradesh**

C. Ramachandraiah

CENTRE FOR ECONOMIC AND SOCIAL STUDIES

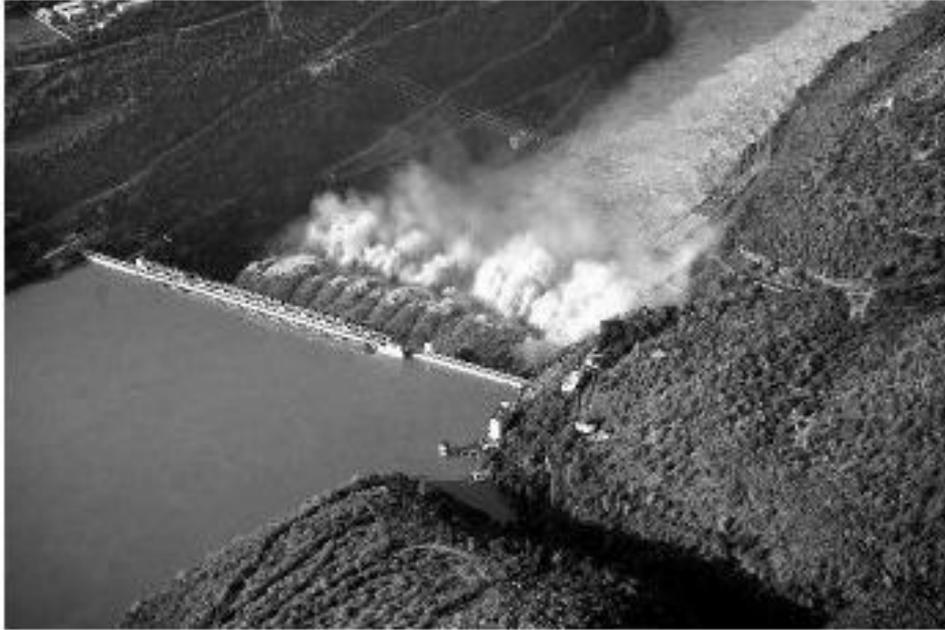
Photo 2: Srisailem reservoir in the peak flood

Maintaining high water level in Srisailem, even after the forecast of heavy rains, raised a controversy because the Nagarjunasagar at the downstream was half-empty. With heavy rains occurring in the Krishna basin from 29 September onwards and all the reservoirs from Srisailem upwards being full, it was possible for emptying the Srisailem reservoir at least from the morning of 30 September. This would have facilitated easy flow of the flood water into the Srisailem reservoir from the overflowing Tungabhadra and Krishna rivers. Instead, the release of water from Srisailem was very slow and gradual and initially less than the quantum of inflows resulting in maintaining the near-full level of the reservoir. For instance, at 19.00 Hrs on 30 September 2009 the inflows and outflows were 2.062 lakh C/s and 1.821 lakh C/s respectively; and at 12-00 Noon on 1 October the inflows and outflows were 9.46 lakh C/s and 9.055 lakh C/s respectively, and the water level was 883.50 ft (Srinivas Rao, 2010). Even at that stage the outflows were less than the inflows. There has never been a clear and convincing explanation by the authorities regarding non-release of water from Srisailem reservoir in anticipation of heavy inflows¹.

The maintenance of the water level at 883.69 feet (about 270 metres) (as against the FRL of 885 feet) at Srisailam Dam is known to have created a backwater effect up to Kurnool town even as large inflows were coming into the reservoir. This situation is known to have aggravated the flooding of the town. The unprecedented water level of 896.5 feet (about 273.4 metres), 11 feet above FRL, at Srisailam Dam was reached on 3 October, and came down to normal level only after six days - by the evening of 9 October.

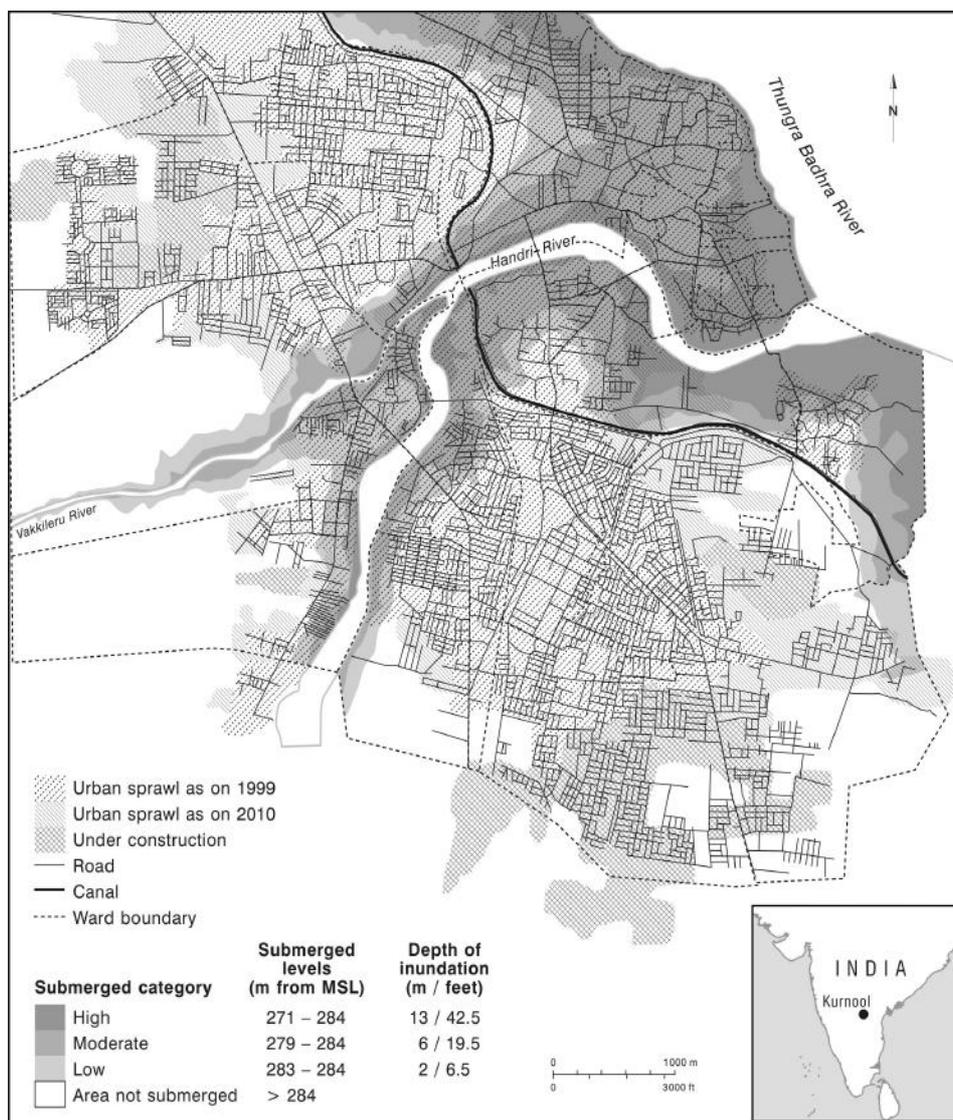
Fig 2: Levels of Submergence

The total submerged area between the contours 271-284 metres works out to 11.56 sq. km or about 30 per cent of the area of the town (Table 7 and Figure 2). The 'high submergence' area at a depth of at least 13 mts (42.5 ft) accounted for 8.6 per cent of the area (3.36 sq. km), and was located in the low lying areas sandwiched between Tungabhadra and Hundri rivers. The 'moderate submergence' area between contours 279-284 metres with a depth of 6 mts (19.5 ft) represented a larger area of 5.36 sq. km or 13.7 per cent. A 'low submergence' area between the contours of 283-284 metres with a depth of 2 mts (6.5 ft) accounted for 2.84 sq. km or 7.2 per cent of the area. The actual depths of submergence on the ground were slightly less than indicated above because of the built-up nature of the urban territory.

Twenty-one wards were completely submerged, affecting about 42 percent of the population, or close to 2 lakh people (Table 8). That these wards constitute only 4.59 sq. km (11.71 percent) of the area indicates the very high population density in the affected areas. These are also the areas where submergence level was the highest and

water took more time to recede. In another 10 wards the submergence was 50-99 percent affecting 14.1 percent more population. Together, these 31 wards accounted for 25.86 percent of the town's area and 56.1 percent of population (about 2.6 lakhs) and were badly affected by the flood.
